INSTALLATION RESTORATION PROGRAM
PHASE II - CONFIRMATION/QUANTIFICATION
STAGE 1

FINAL REPORT
FOR
AIR FORCE PLANT 4
FORT WORTH, TEXAS

VOLUME 1. REPORT TEXT

DECEMBER 1987

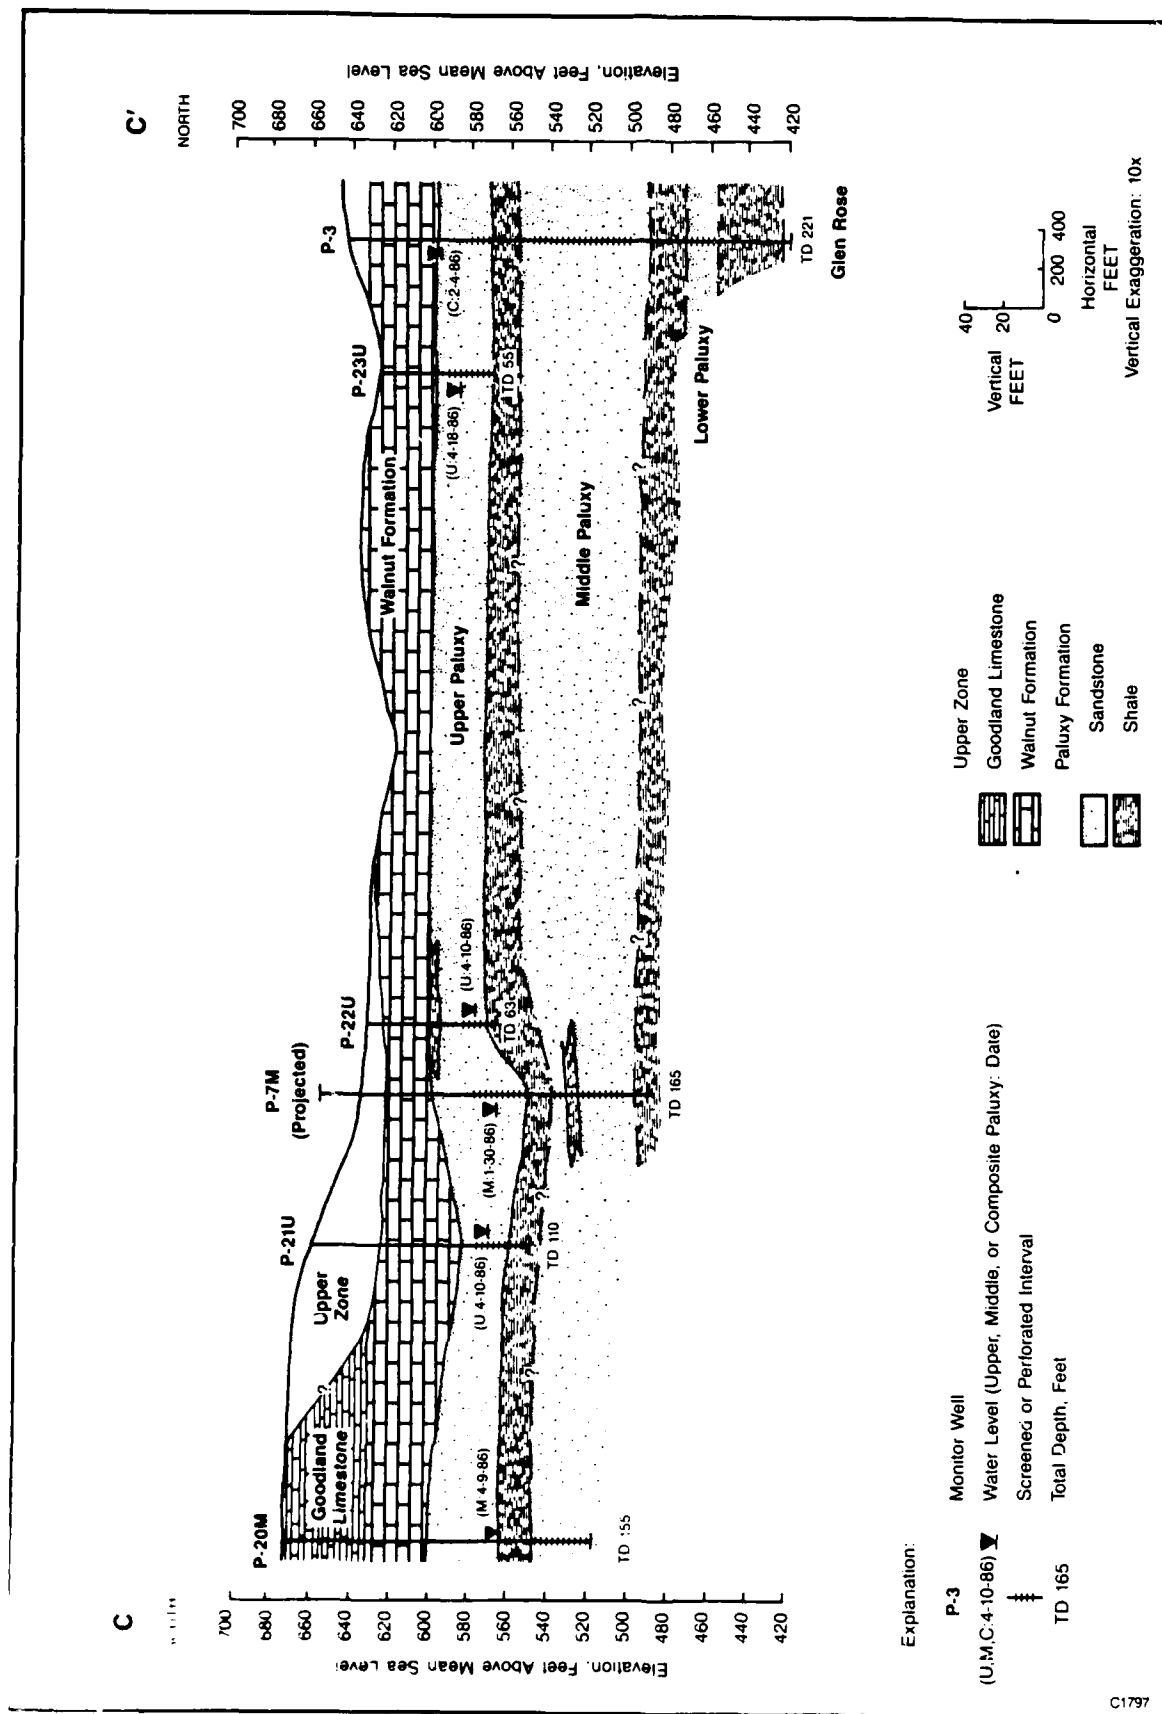
Figure 4.1.1-1. Geologic Cross Section C-C', AF Plant 4, Texas

Hydrogeologic data gathered for this investigation consisted of water-level readings at existing and new upper zone and Paluxy monitor wells.

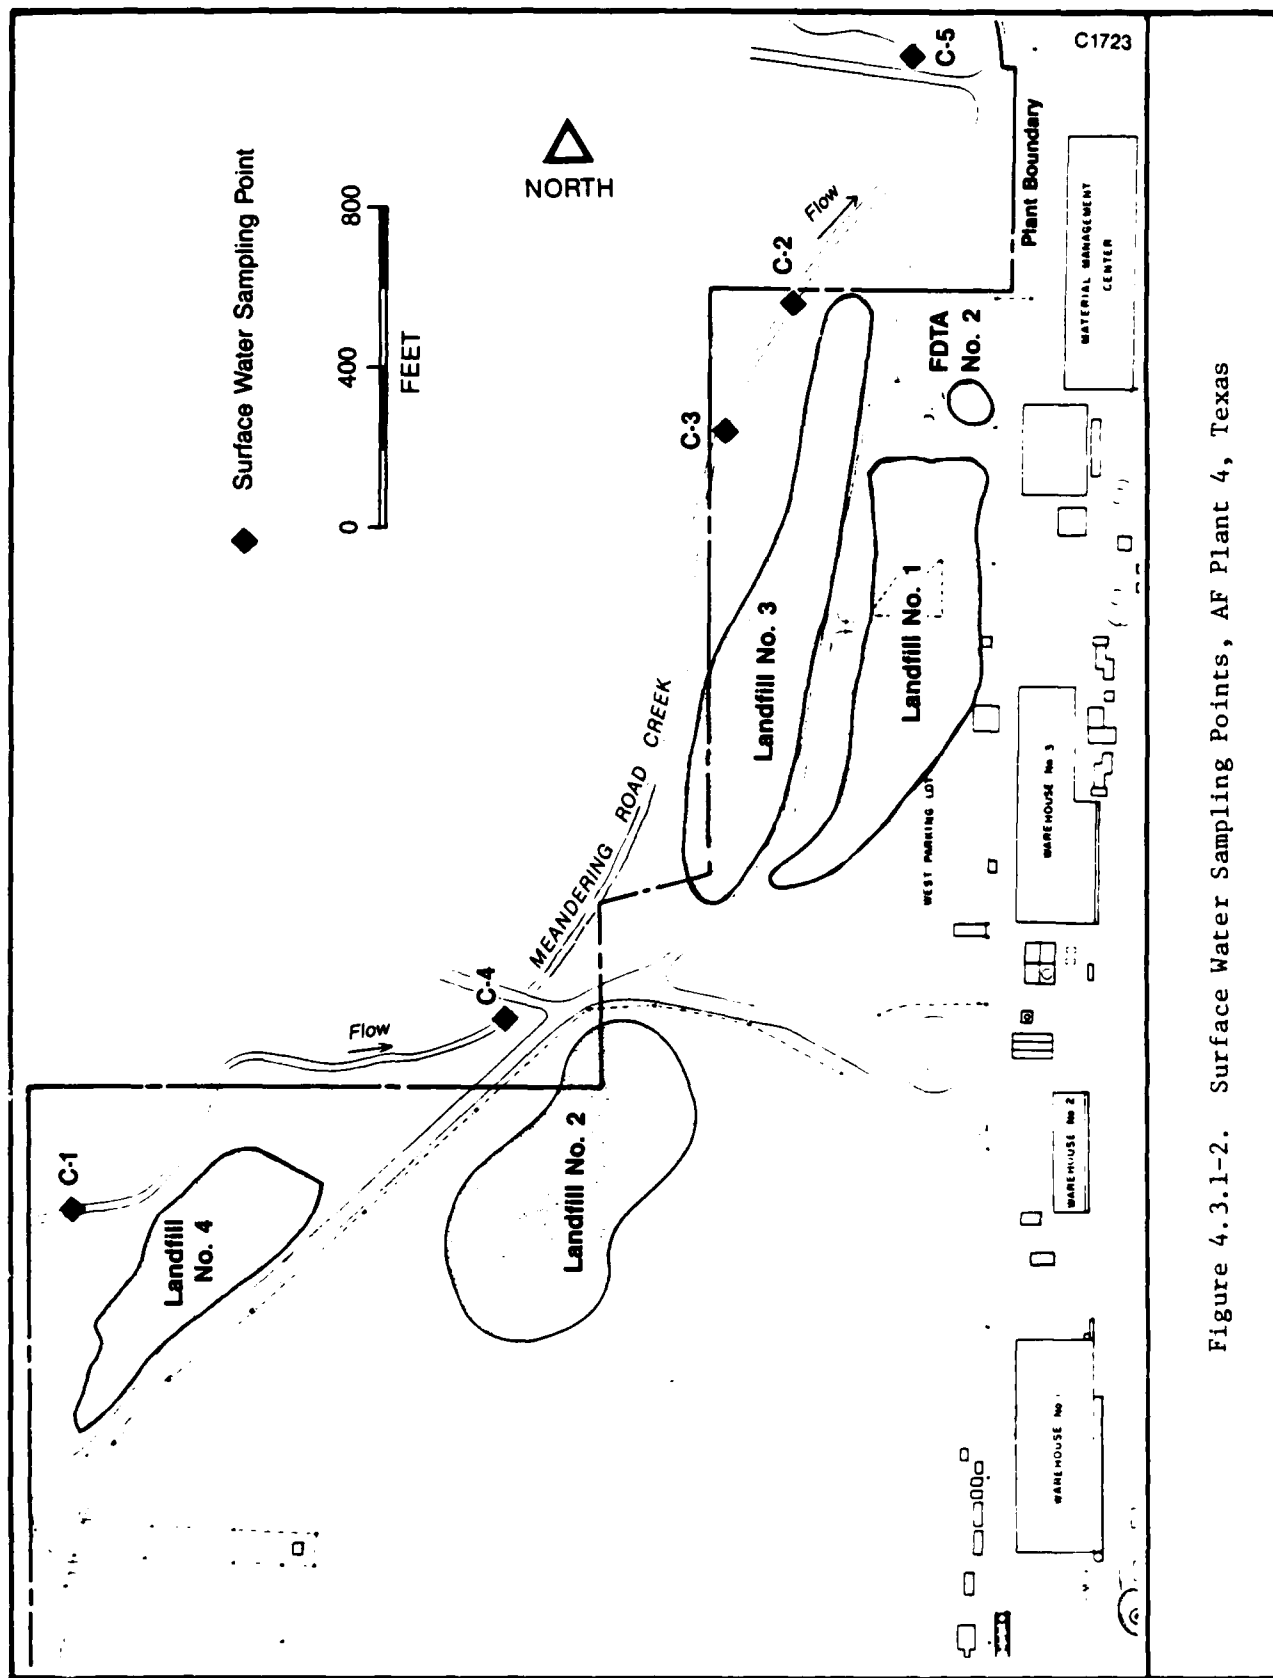
Figure 4.3.1-2. Surface Water Sampling Points, AF Plant 4, Texas

the statement of work. Surface water samples were collected and analyzed from Meandering Road Creek west of the landfill at the following locations: C-1, C-2, C-3, C-4, and C-5. The C-1 and C-4 locations are upstream of the landfill, while the other locations are downstream of the landfill and other disposal sites. Other water samples were collected and analyzed from French Drains 1 and 2, the drain pipe and the creek seep. St-5 outfall was dry at the time of sampling. Groundwater and surface water samples were analyzed for volatile organic compounds by EPA Methods 601 and 602, acid and base/neutral extractable compounds by EPA Method 625, and heavy metals by EPA Methods 200.7, 206.2, 239.2, 245.1, and 270.2.

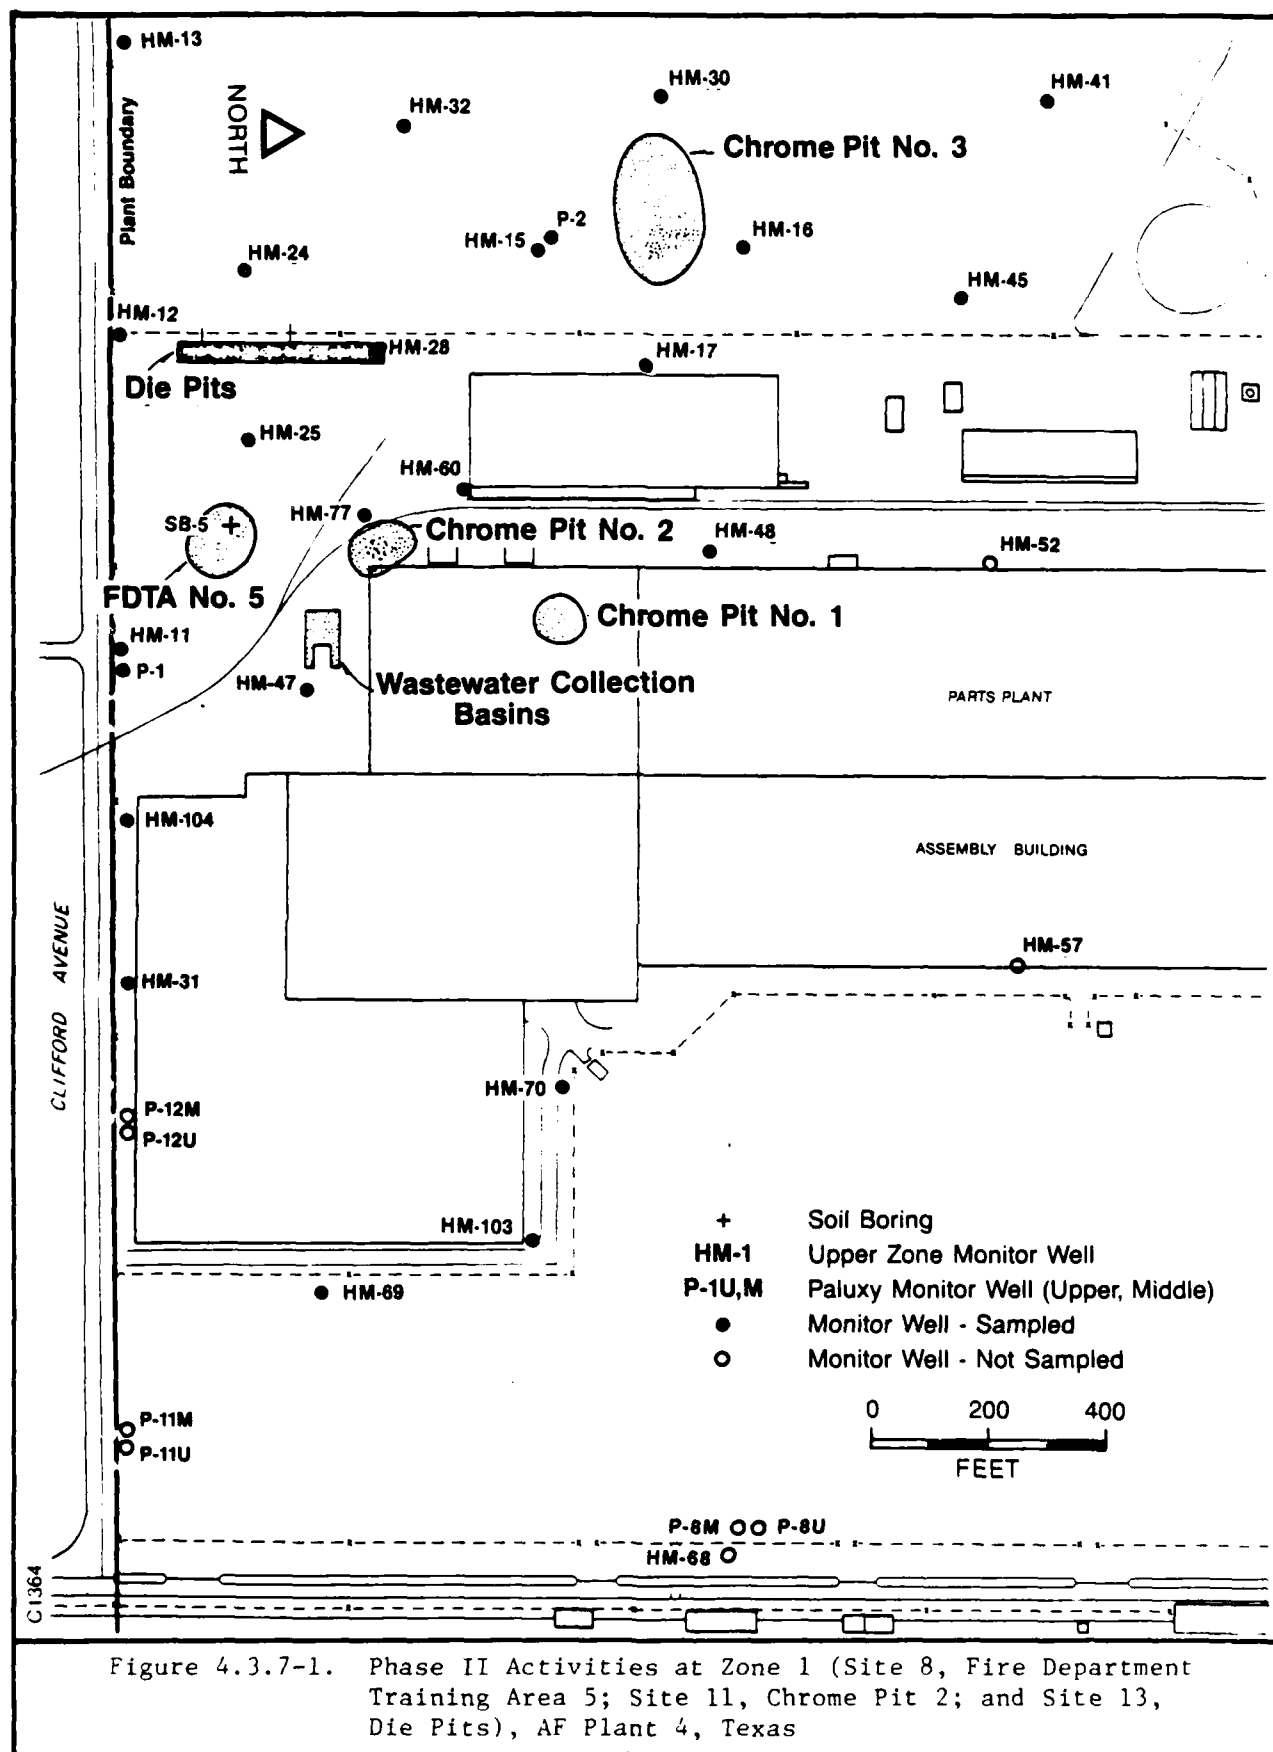
Figure 4.3.7-1. Phase II Activities at Zone 1 (Site 8, Fire Department Training Area 5; Site 11, Chrome Pit 2; and Site 13, Die Pits), AF Plant 4, Texas

Previous groundwater analyses indicated elevated levels of organic compounds at this site, which consisted of a shallow pit into which waste fuels, oils, or chemicals were deposited and ignited for training exercises. It is located in the die yard area south of Warehouse 1 and has been graded and paved.

The IRP Phase II Stage I activities at Zone 1 consisted of the collection and analysis of groundwater samples. Monitor wells at this site include HM-11, 12, 24, 25, 28, 60, 77, and P-1. Figure 4.3.7-1 shows the locations of these sampling points and the physical features of the sites.

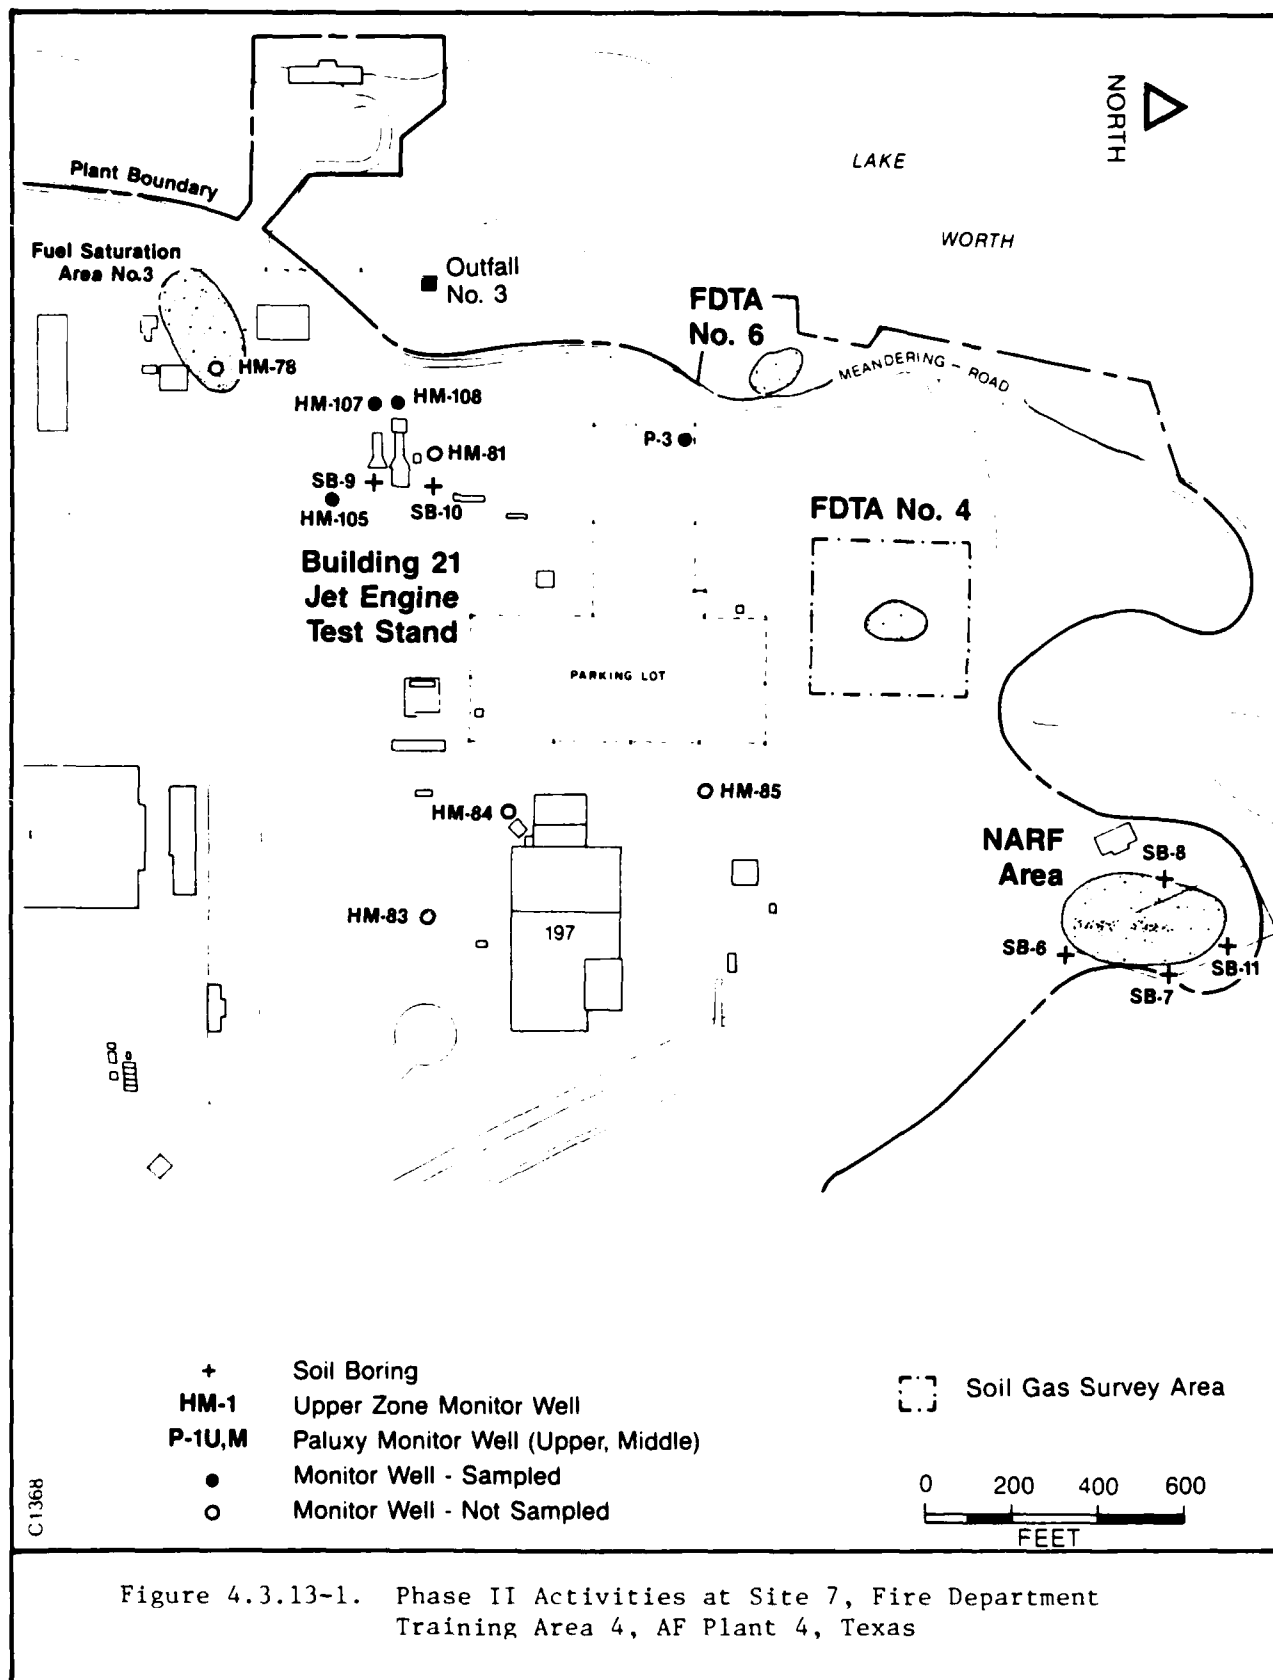
Figure 4.3.13-1. Phase II Activities at Site 7, Fire Department Training Area 4, AF Plant 4, Texas

During the late 1960s, FDTA 4 was reportedly the site of fire department training exercises which used about 250 gallons per exercise of waste fuels and oils. Figure 4.3.13-1 shows the reported location of the site.

Activities at FDTA 4 consisted of a soil-gas survey conducted to determine the location of the old fire training area. Results of the soil gas survey appear in Appendix I. After 28 soil-gas samples had been taken and no definite hydrocarbons noted, AF Plant 4 fire department personnel were requested to pinpoint the fire department training area noted in the Phase I report. The fire department personnel contacted stated that no FDTA had ever existed at this location; therefore, no further work was conducted at this site.

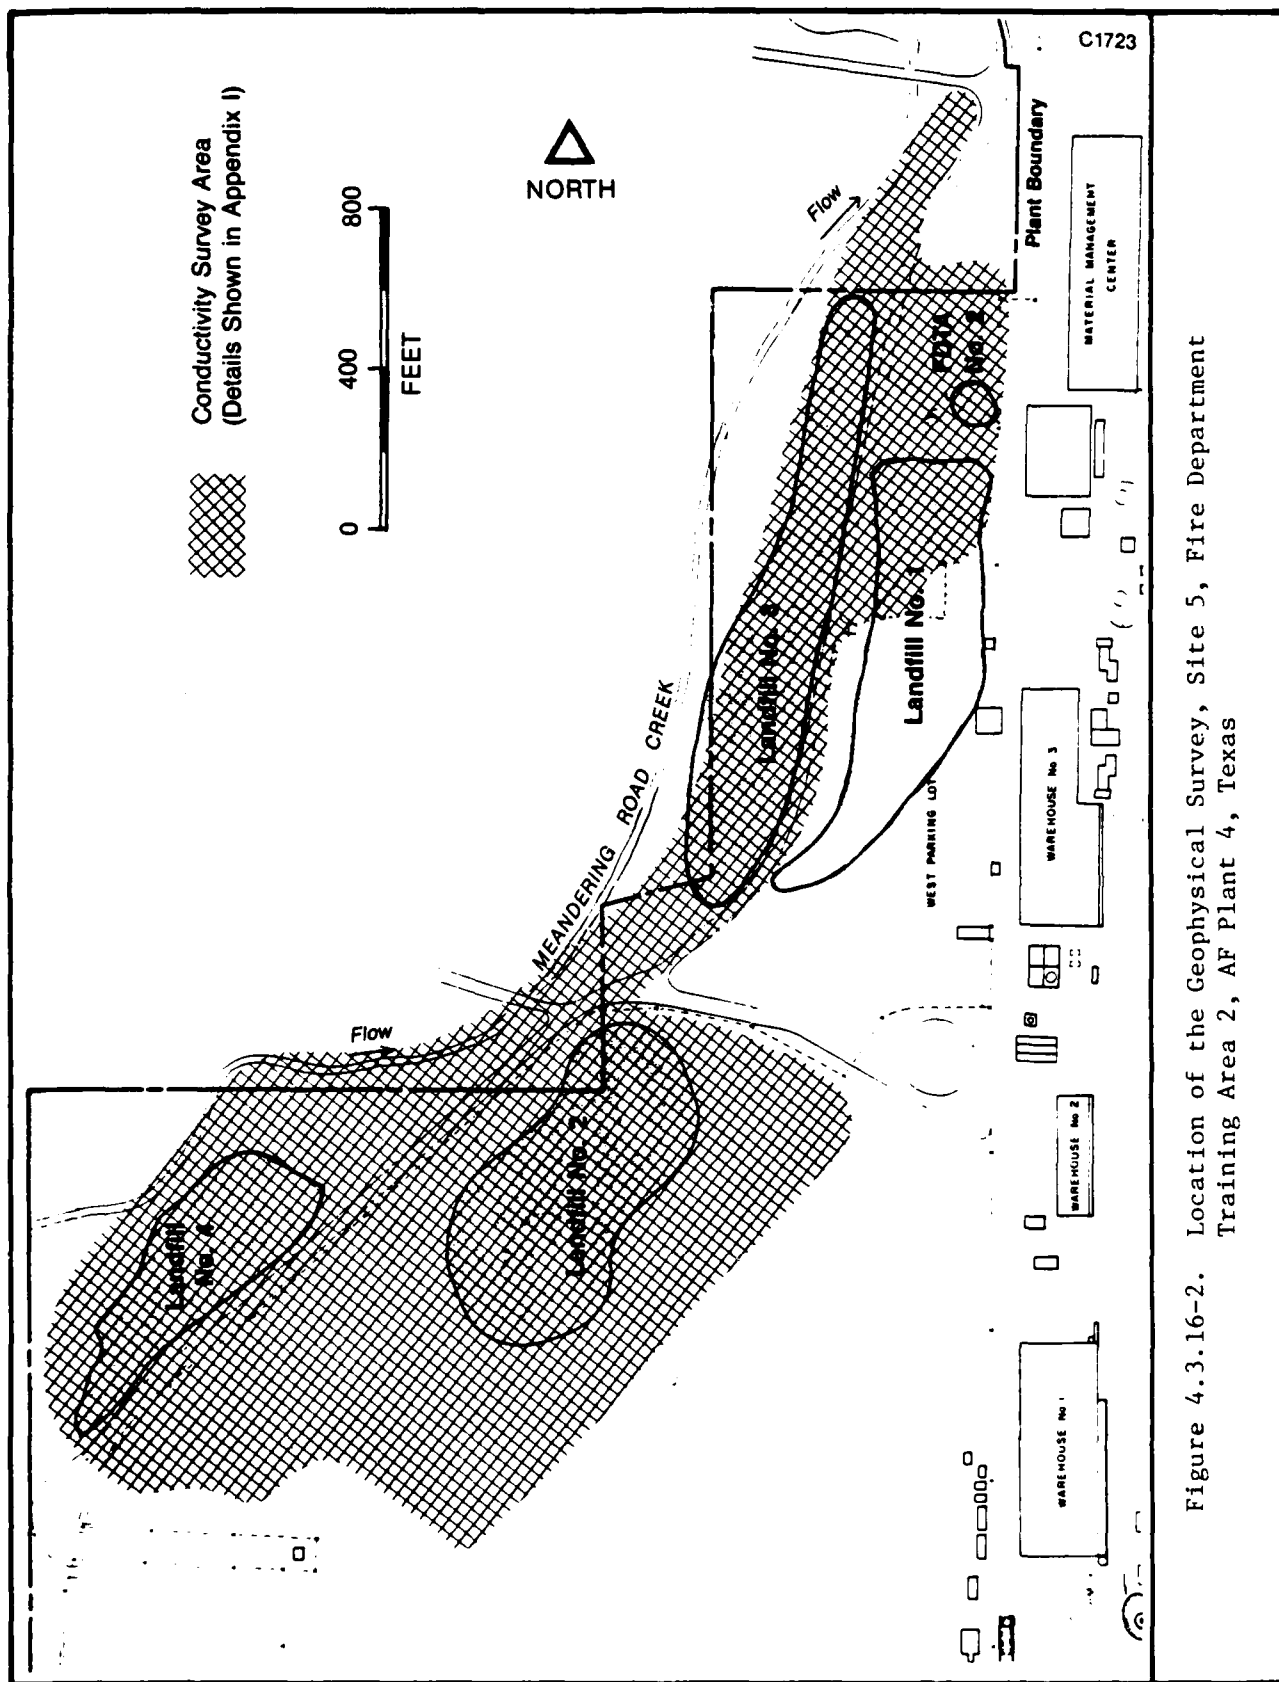
Figure 4.3.16-2. Location of the Geophysical Survey, Site 5, Fire Department Training Area 2, AF Plant 4, Texas

zone, may indicate moderate amounts of fill. The third zone located in the southwestern corner of the area, is interpreted to be large amounts of metal.

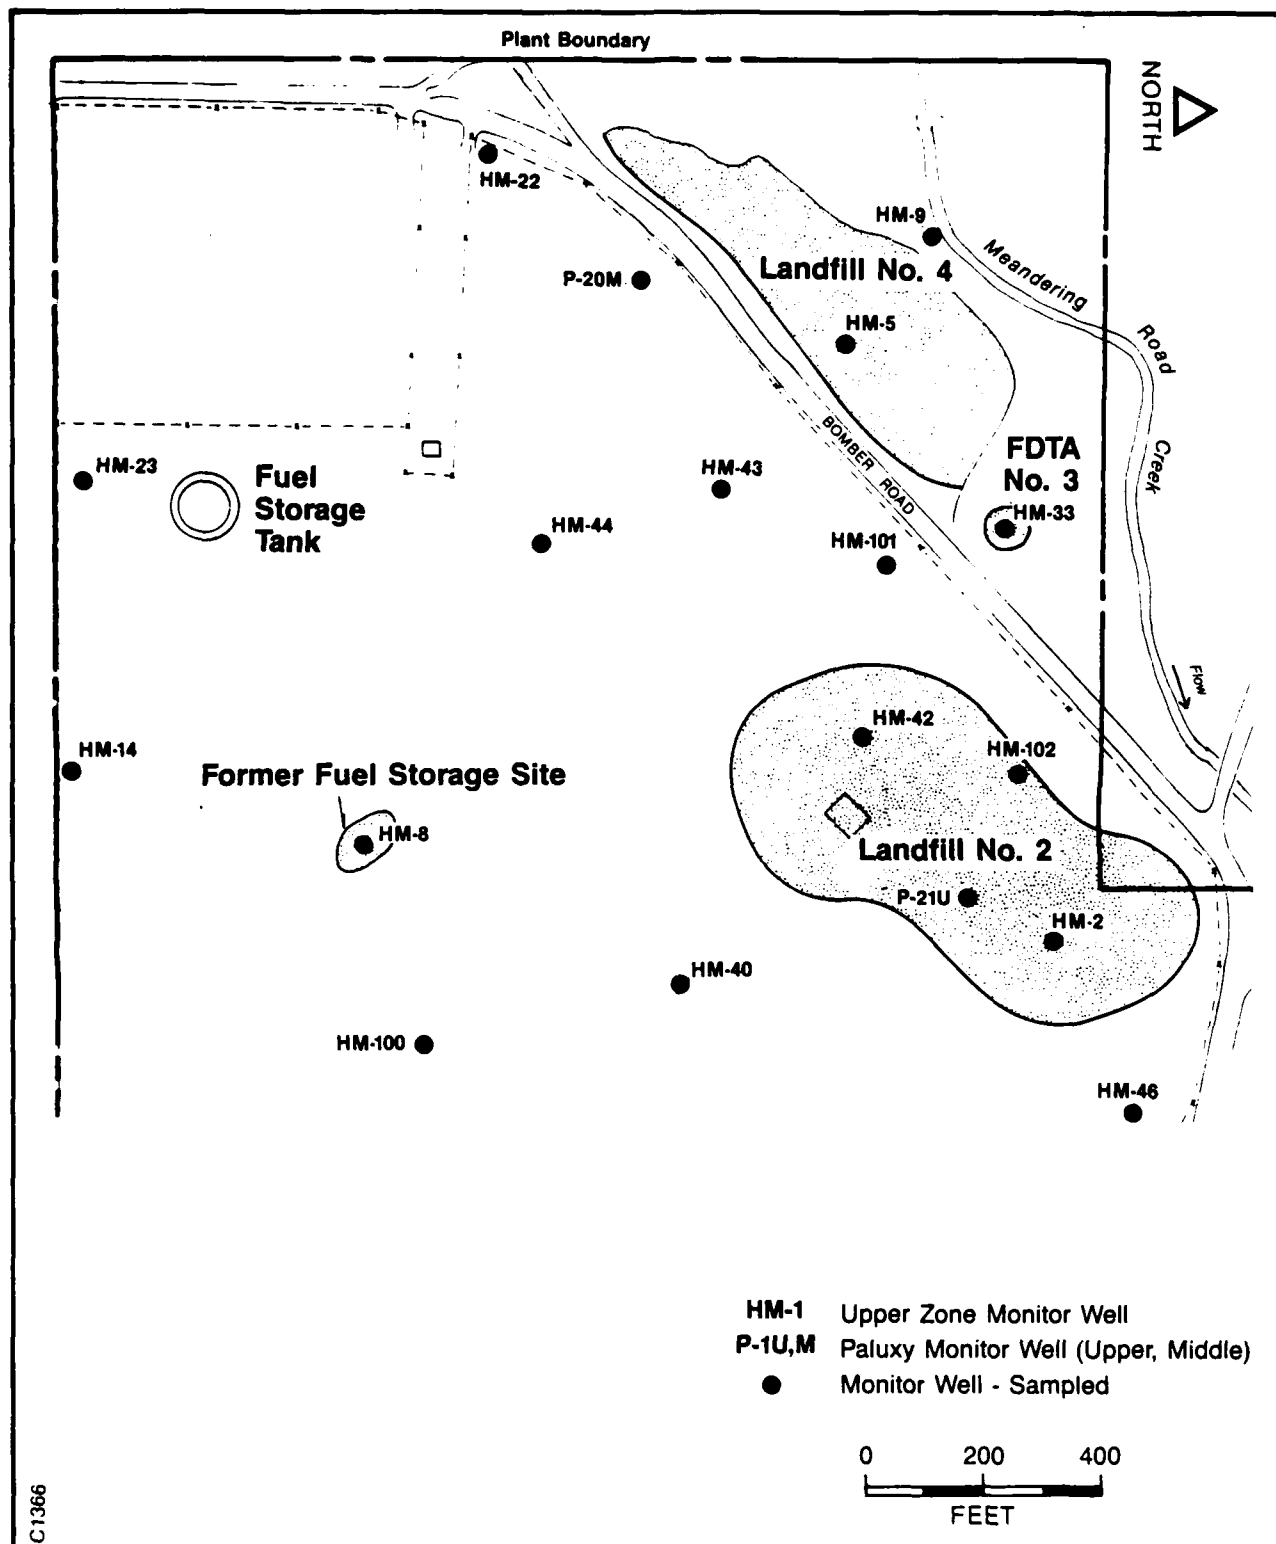
Figure 4.3.22-1. Phase II Activities at Fuel Storage Tank, AF Plant 4, Texas

The lithologic log of monitor well HM-23 (Hargis and Associates, 1985) gives shallow subsurface information for the Fuel Storage Tank site.

The upper zone is about 42 feet thick and consists of silty to sandy clay grading down into sand and gravel and clayey sandy gravel. About 8 feet of Walnut Formation were encountered. The Goodland Limestone is absent at this location.

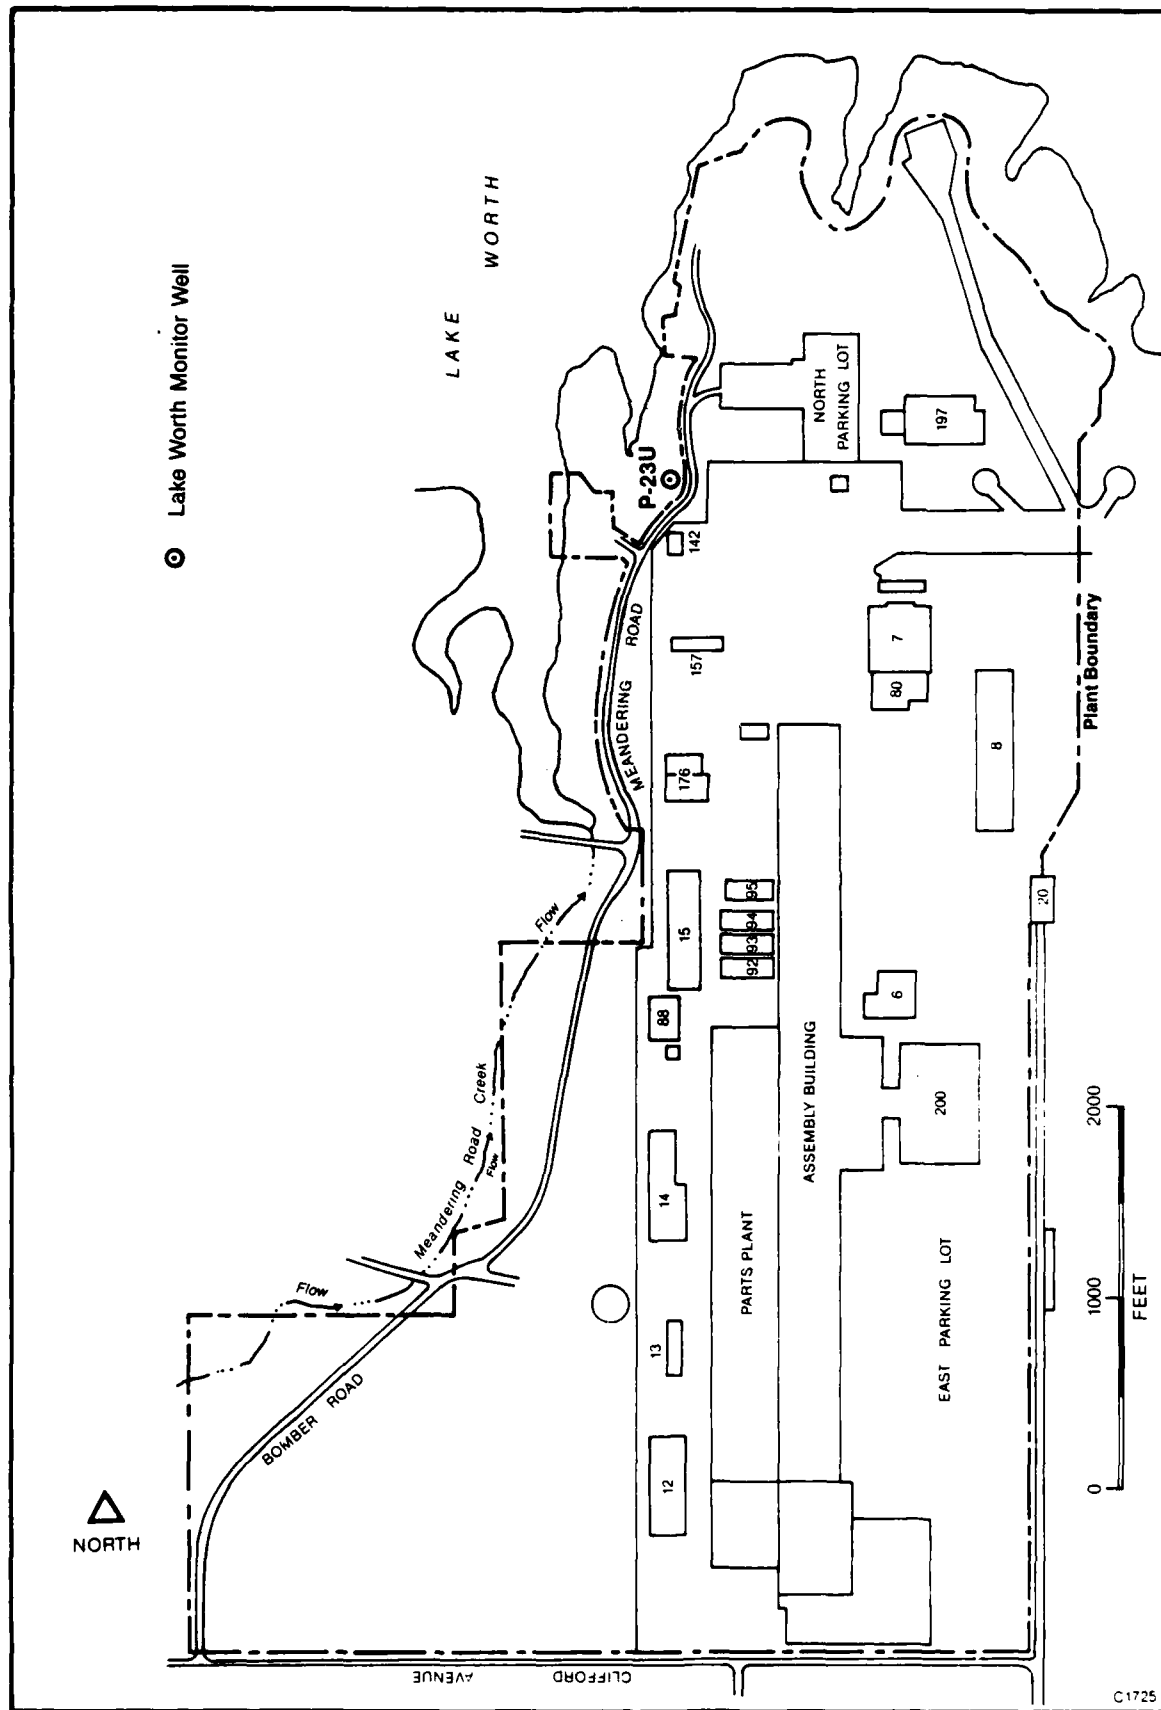
Figure 4.3.23-1. Location of Lake Worth Monitor Well (P-23U), AF Plant 4, Texas

The upper zone is absent at this site. The Walnut Formation was encountered at the surface when drilling and is about 25 feet thick. It is

composed of layers of fossiliferous limestone and calcareous shale. Monitor Well P-23U penetrates approximately 20 feet of sand in the Upper Paluxy Formation.

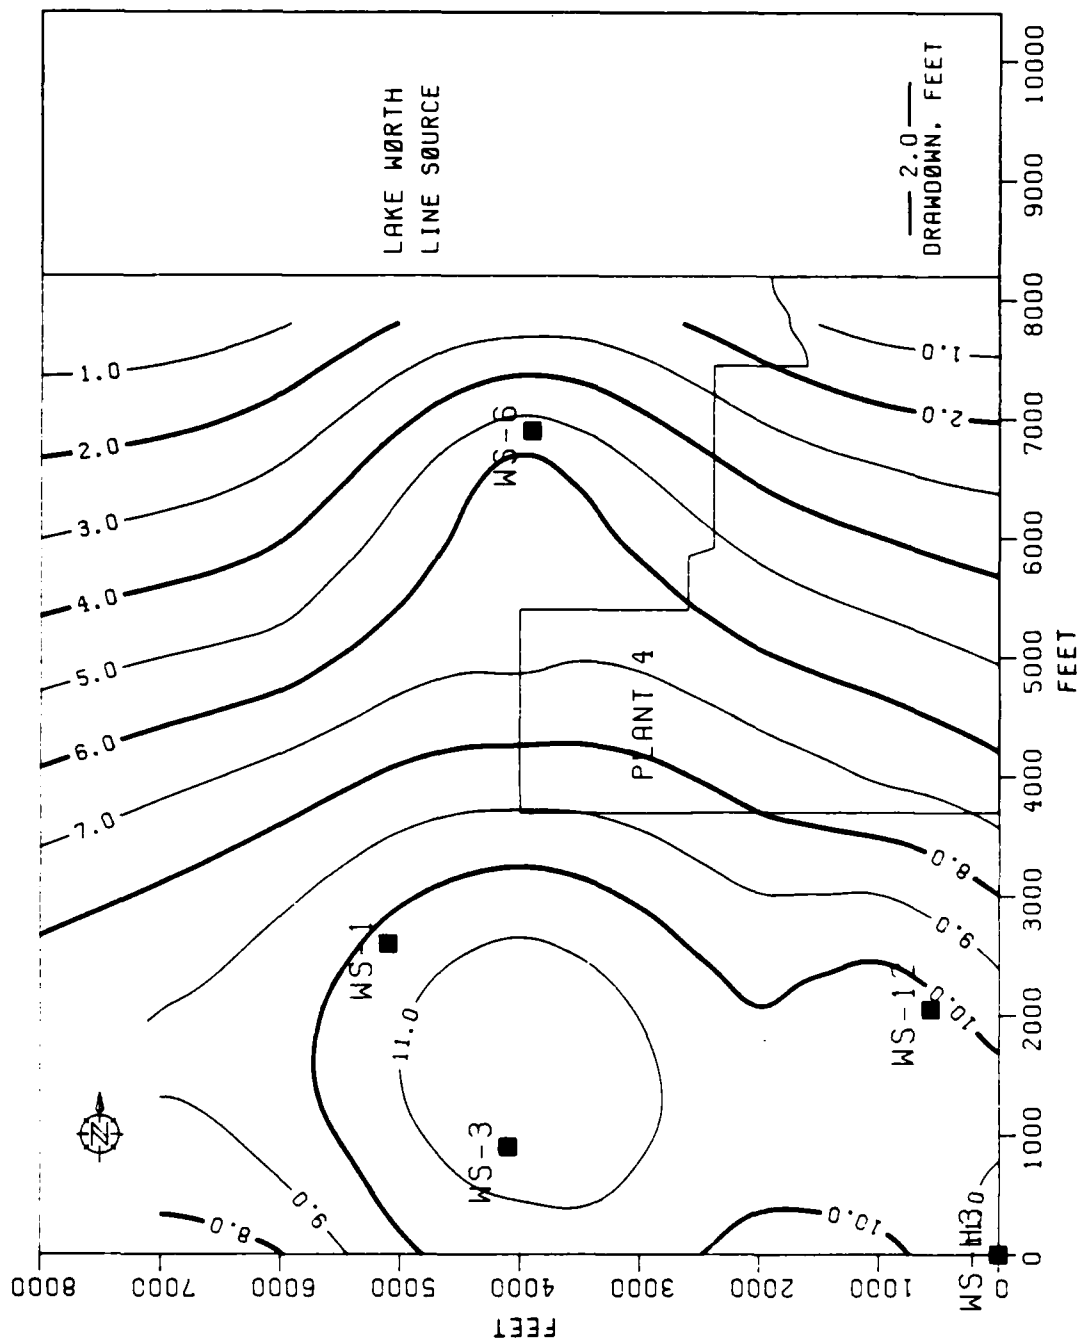
Figure 4.3.24-6. Simulated Drawdowns in the Paluxy Aquifer from White Settlement Municipal Wells - Year 20

Year 20 (Figure 4.3.24-6) After 20 years the drawdowns begin to achieve steady state conditions. The predicted drawdowns near wells WS-H3, WS-3, and WS-1 show very little change from year 15. Drawdown along the southern perimeter of Plant 4 ranges between about 6.5 feet in the

southeastern corner to 9 feet in the southwestern corner of the plant. Drawdown remains fairly steady in the area adjacent to well WS-6; however, Lake Worth continues to recharge this area at a rate approximately equal to the rate of discharge from the well.
